Navajo Abandoned Uranium Mine

Site Screen Report

Todakonzie No. 1 AUM Site

August 2010

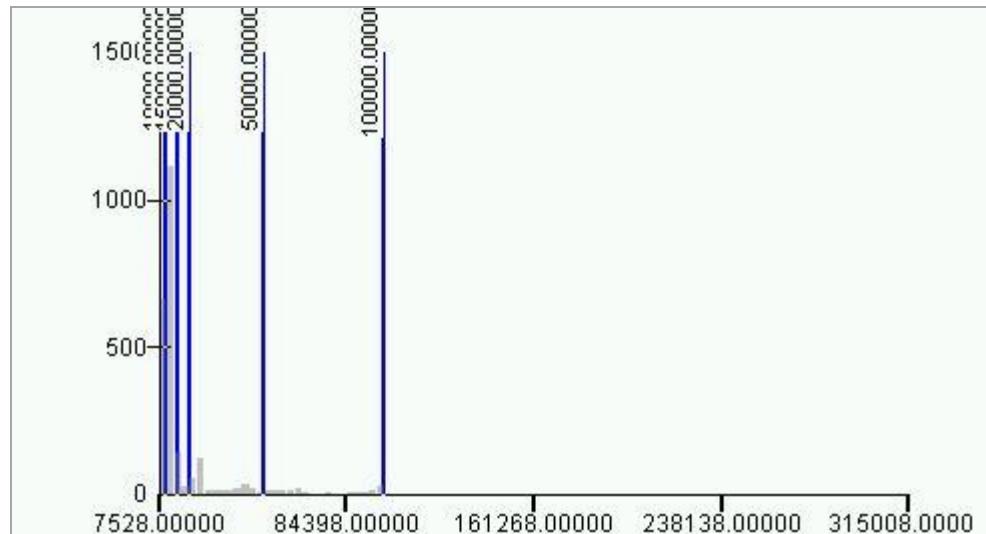
Distribution Chart and Statistics:

The following chart and statistics were generated by ESRI ArcGIS 9.3.1, and show the general distribution of the site gamma radiation measurements. The horizontal X axis represents the gamma radiation reading levels in cpm (lowest levels to the left). The vertical Y axis represents the frequency of each gamma radiation level.

Count:	2470
Minimum:	7528.00000
Maximum:	315008.00000
Sum:	52232498.00000
Mean:	21146.76032
Median:	11481.50000
Standard Deviation:	30060.91655

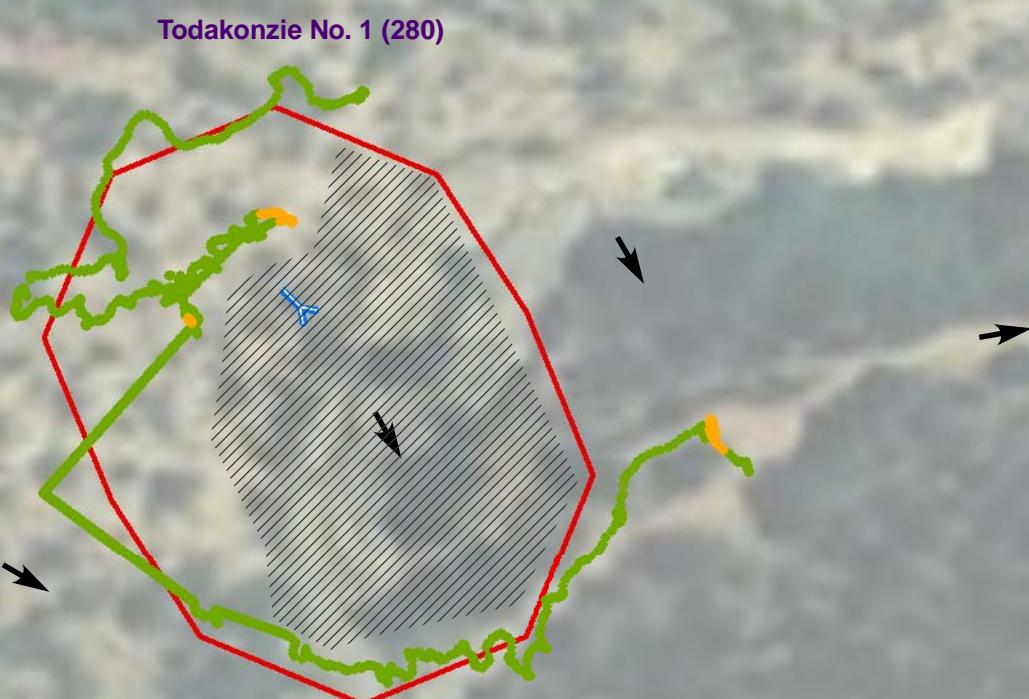
Figure 1 - Gamma Radiation Measurements, Above Two Times Background
Todakonzie No. 1 (280)
Beclabito Chapter, Navajo Nation

A total of 2,470 gamma radiation measurements were collected from the mine site, ranging from 7,528 cpm to 315,008 cpm. Measurements collected in the vicinity of the waste debris were found at levels ranging from approximately 150,000 cpm to 315,000 cpm, near the adit at levels up to approximately 96,000 cpm, and near the rim strip ranging from approximately 50,000 cpm to 80,000 cpm. The measurements are represented in Figures 1 and 2.
